GREAT POND

WATERSHED-BASED MANAGEMENT PLAN

(2021-2031)

Kennebec County
Soil and Water
Conservation District

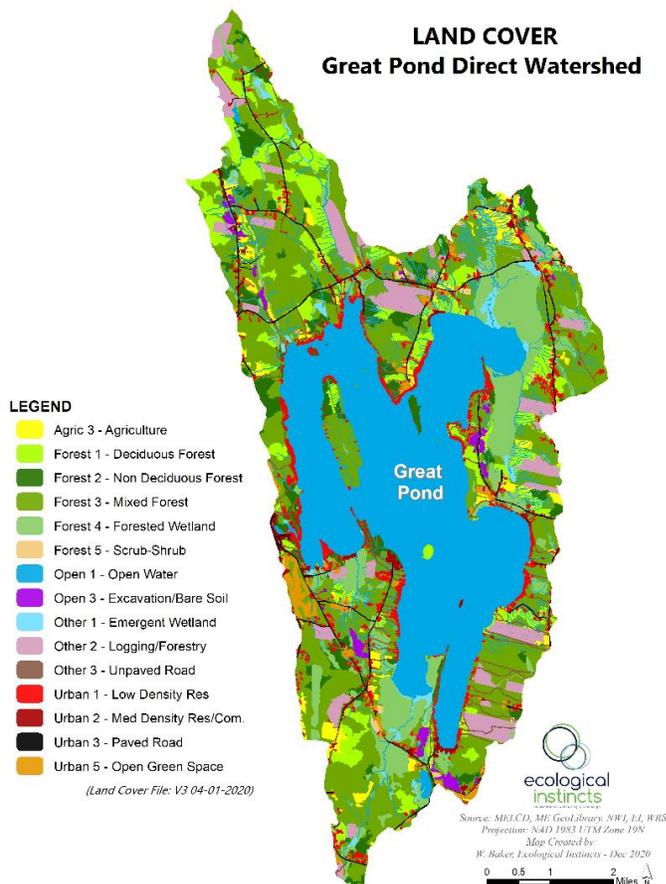
Figure 5. Updated land-cover map for Great Pond.

The resulting updated land-cover file provides a more accurate representation of current land cover within the Great Pond watershed (Figure 5, Table 2). The most significant changes to land cover were the addition of low- and mid-density residential and commercial development throughout the watershed (Figure 6). These data are foundational in the watershed model used to estimate phosphorus loading in Great Pond (Section 4). In the model, a phosphorus export coefficient is assigned to each land-cover type to represent typical concentrations of phosphorus in runoff from those land-cover types. Unmanaged forested land, for example, tends to deliver very little phosphorus downstream when it rains, while row crops and high-density urban land export significantly more phosphorus due to fertilizer use, soil erosion, car and factory exhaust, pet waste, and many other sources. Smaller amounts of phosphorus are also exported to lakes and streams during dry weather under base flow conditions. A breakdown of land-cover types by area and contributing phosphorus loads to the lake is presented in Section 4.

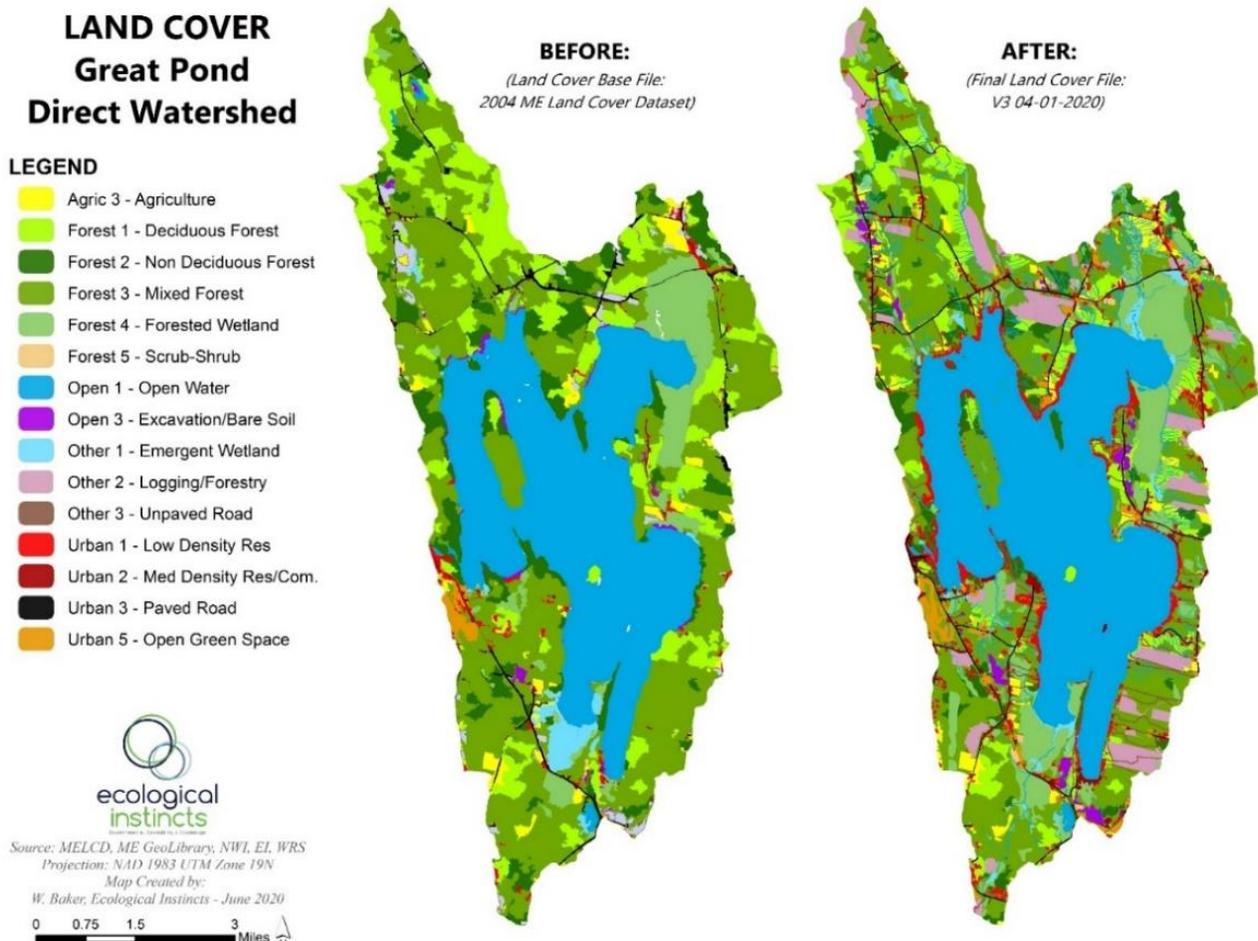
Figure 6. "Before" (left) and "After" (right) land-cover file modifications.

between the aerials and the MELCD file were found, changes were made by manually editing polygons. The State road layer (NG911 roads), stream layer, and an NWI wetlands layer were overlaid on the updated land-cover layer and relabeled appropriately.

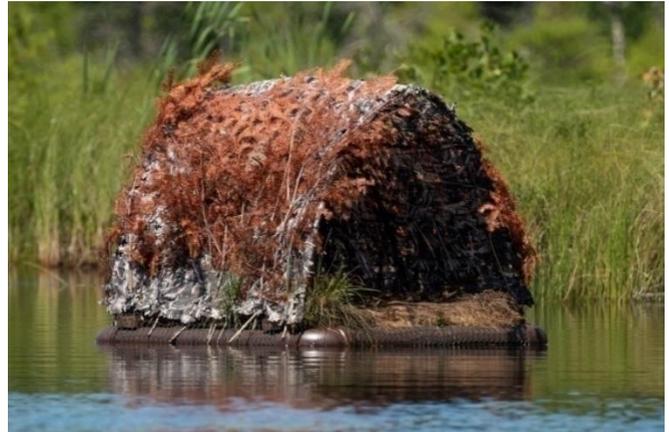
Floating artificial nest deployed on Great Pond in 2020. (Photo Credit: Dick Greenan, BLA)

A symbol of summertime on Maine lakes, loons are common on Great Pond, with 61 adult loons and 2 chicks counted on the lake in 2019 (ME Audubon, 2020). BLA kicked off the Loon Preservation Project in 2019 and hired Loon Conservation Associates (LCA) to conduct a study of loons on Great Pond and Long Pond between 2019 – 2021. 2020 loon monitoring results indicate 12 territorial pairs on Great Pond. Of the 12 pairs identified, four nested, and one nest was successful in hatching a single chick that survived to fledge. As part of this project BLA constructed and installed four floating artificial nests in Long Pond and Great Pond in 2020. Two of the artificial nests were used with a 100% success rate (LCA, 2020).²⁴

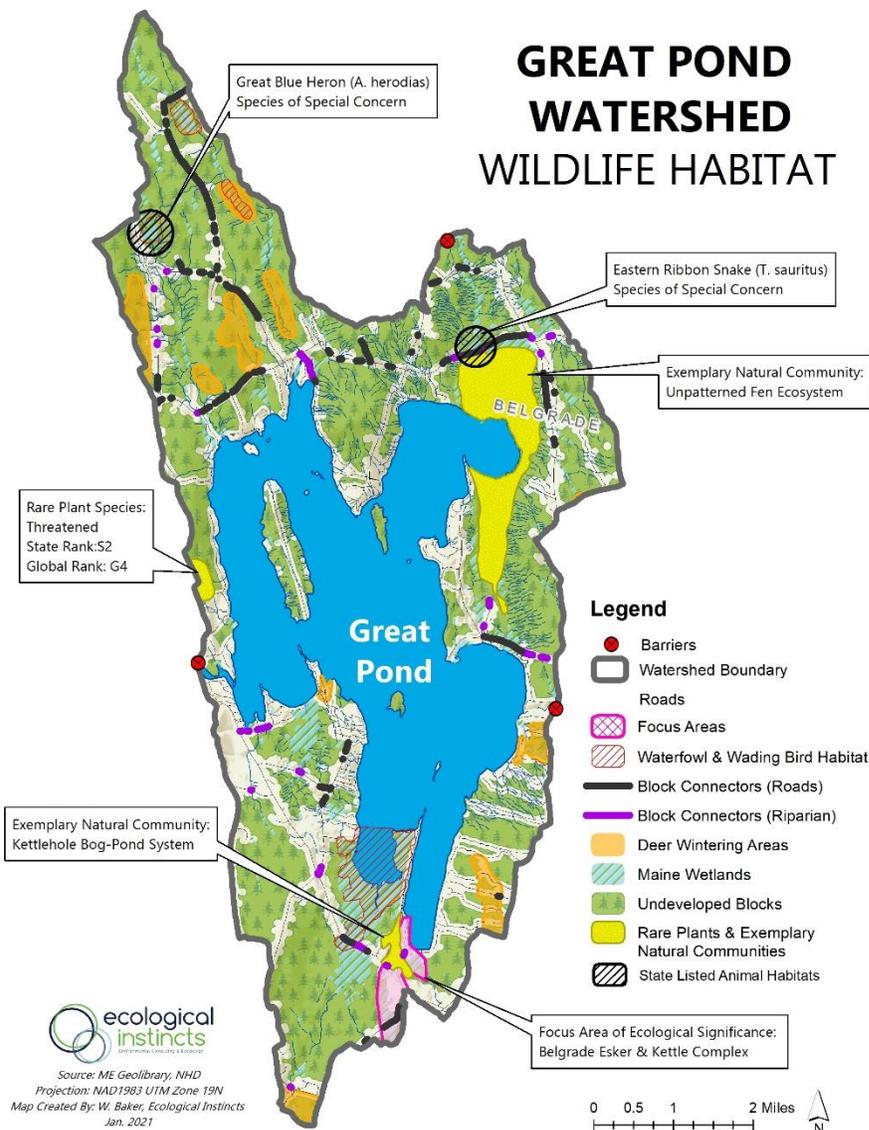
Figure 15. Wildlife habitat in the Great Pond watershed.

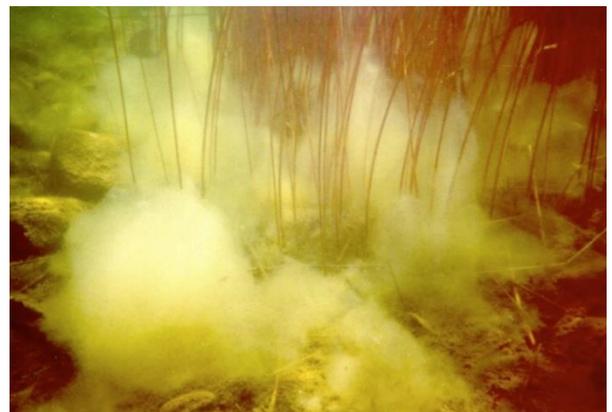
Metaphyton mass. (Photo Source: Lake Stewards of Maine, photo provided by Betsy & Dick Enright.)

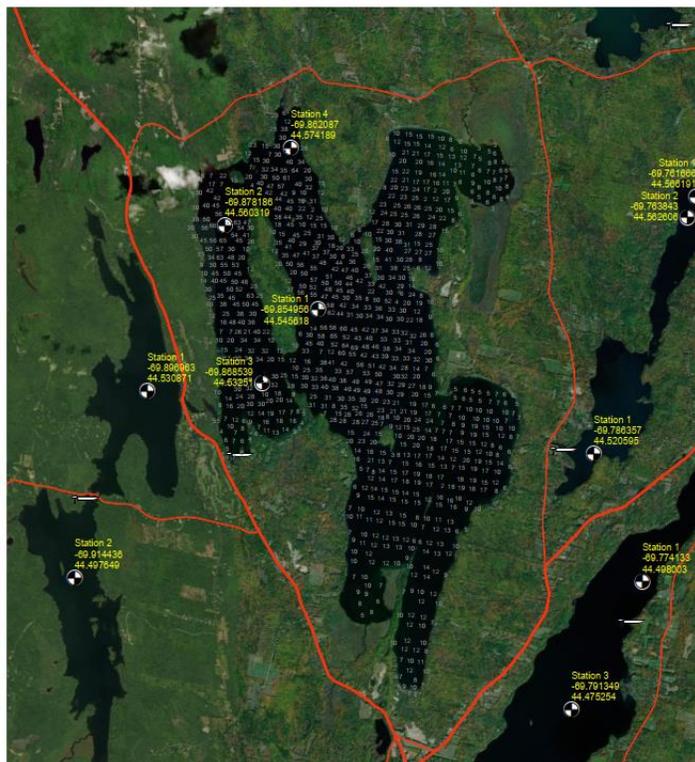
Great Pond MIDAS # 5274
Belgrade, Kennebec Co. - Delorme Page 20(E4) - 8509 acres

Figure 20. Water quality monitoring stations in Great Pond (Source: LakesofMaine.org)

Water quality data have been collected by Maine DEP and Lake Stewards of Maine (formerly the Volunteer Lake Monitoring Program) in cooperation with the Belgrade Lakes Association since 1970 at the deep holes (Stations 1 through 4, Figure 20). This includes 49 years of data³² collection over the 49-year monitoring period. More recent, and more intensive monitoring has been completed by Colby including deployment of "Goldie" in 2014 - a research buoy that collects information about the physical and biological conditions in the lake. Great Pond's buoy is a node in an international observation network (GLEON) to assess lakes across the world. In addition, a three-year intensive water quality study (2015-2017) was conducted by Colby researchers which included weekly collection of dissolved oxygen/temperature/pH profiles, water clarity, nutrients, metals and phytoplankton, as well as sediment sampling. This intensive monitoring effort has continued through 2020, led by staff at 7 Lakes and Maine Lakes Resource Center in collaboration with Colby College interns.

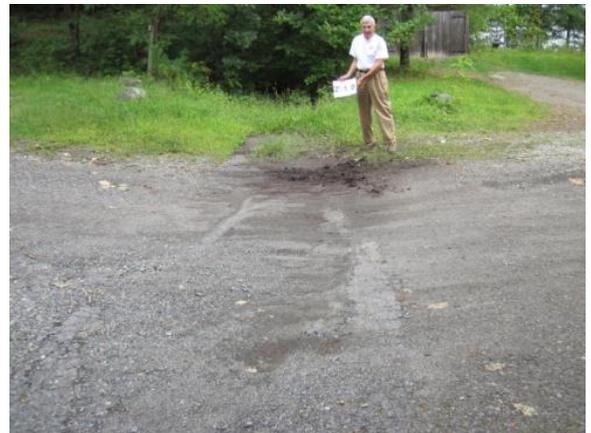
Improvements are needed at a commercial parking lot in Sector 20 to prevent sediment from getting into the lake.

- Sector 20** Review original design plans for existing BMPs at Taconnet Parking Lot and develop new plans to address runoff
- Sector 21** Steep eroding bank and multiple NPS issues stemming from walkways, roofs and tent platforms on Pine Island. Good YCC project.

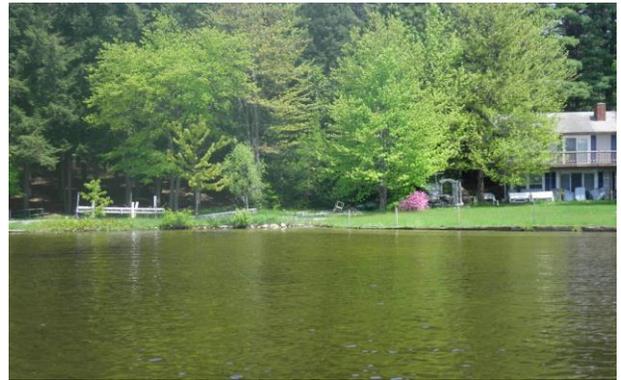
Shoreline survey photo on Great Pond (Zone F) taken in 2011 as part of the of the Belgrade Lakes Watershed Sustainability Project. (Source: Colby College)

In 2011, researchers at Colby College organized shoreline photographic surveys for all of the Belgrade Lakes. The shoreline of Great Pond was divided into nine sections, and georeferenced photographs were taken to document shoreline development and buffer conditions around the lake. The photos were provided to towns to help track changes in the shoreland zone. The surveys confirm that many properties on Great Pond have very limited to non-effective shoreline buffers.

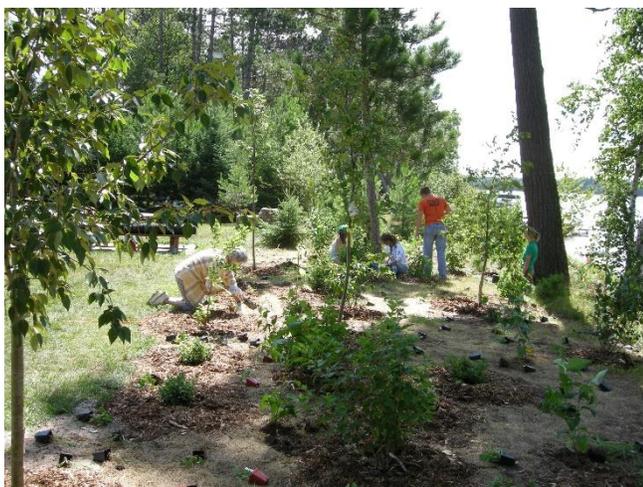
Shoreline buffer installation on a lake front property.

Installing an effective shoreline buffer can be one of the easiest ways to help improve water quality. Naturally vegetated shorelines are often the “last line of defense” for trapping and treating polluted stormwater runoff before it gets to the lake. A healthy, vegetated shoreline will not only act as a buffer between the pond and adjacent shoreline development, but will also provide great benefit to wildlife as more species live in (and rely on) shoreline riparian zones than any other habitat type (Maine Audubon, 2006). Increasing development pressures throughout the watershed, and especially within the shoreland zone of Great Pond, and the effects of climate change (more frequent and more intense precipitation and increased volume and velocity of stormwater runoff) means that healthy, vegetated shoreline buffers will be even more important for achieving water quality goals and maintaining a healthy lake ecosystem.

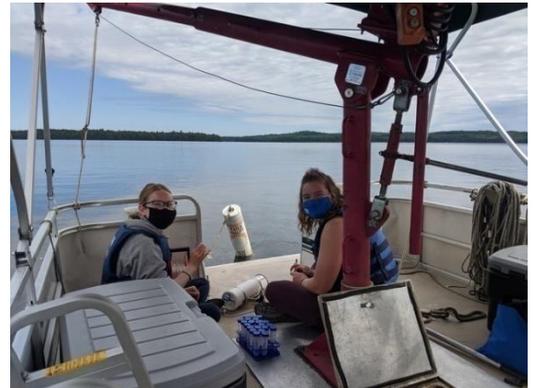
7 Lakes interns collecting data on Great Pond. (Photo: 7 Lakes)

- 1) **Water Clarity** measured biweekly April through October.
- 2) **Temperature, Dissolved Oxygen, pH, and Conductivity** profiles collected biweekly April through October and monthly during the winter.
- 3) **Phosphorus & Metals** collected from profile grab samples using a grab sampling device biweekly every 2 m from 0 – 20 m April through October and monthly during the winter.
- 4) **Phytoplankton** collected biweekly May through October at 2 m and analyzed using a FlowCam.
- 5) **Chlorophyll-*a*, DO, Temp, PAR** collected continuously from Goldie at Station 2 at 2m and 6m (Chl-*a*), at 4 depths for DO, at odd meters (temp), and above the surface and 2 m (PAR).
